Manhole Inspection Summary

Manhole # S13MM_003MH

Insp Date: **9/26/07 3:33 PM**

Location Address: **2800 BLOCK ELGIN AVE** Cross Street: **POPLAR GROVE**

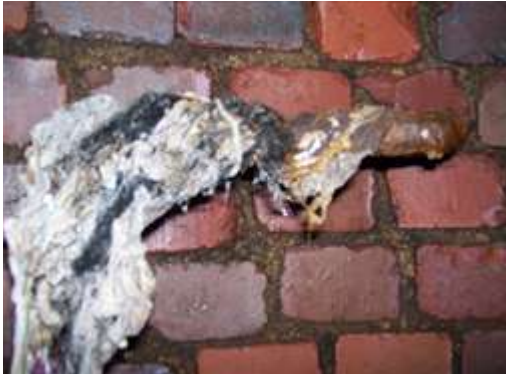
Defect 1

Surcharge ☒ **Evidence Of Surcharge** Depth: **3** (ft.) ☐ Active Surcharge Present

EVIDENCE OF SURCHARGE

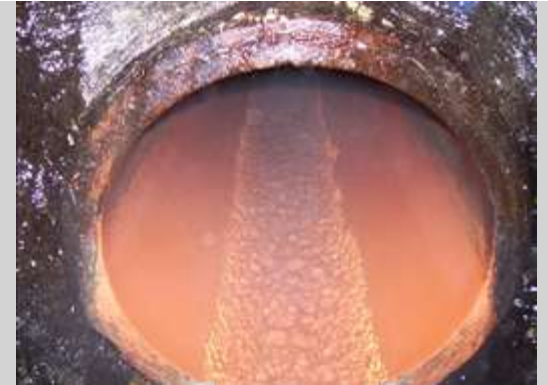
12 O'Clock Outflow

21 in. Circular Gravity Sewer
Pipe Out @ 12 O'Clock

Pipe Height: (in.) Direct
Pipe Material: **Clay** ☐ Pipe Lined
Invert Depth: **31.72** (ft.) Flow Characteristics: **Fast**
Deposits: ☒ None ☐ Mud ☐ Sludge ☐ Debris ☐ Grease
Silt Depth: (in.) Deposits Extent:
Infiltration: **None** Pipe Seal Cond: **Sound**

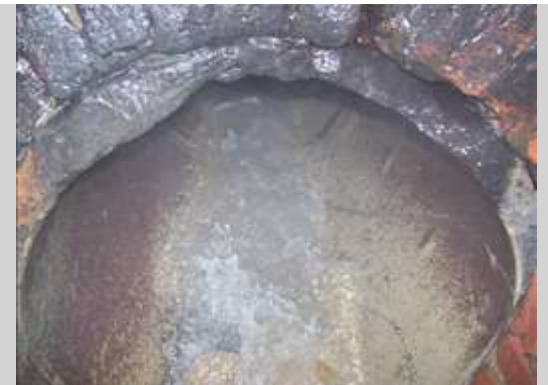
6 O'Clock Inflow

18 in. Circular Gravity Sewer
Pipe In @ 6 O'Clock

Pipe Height: (in.) Direct
Pipe Material: **Clay** ☐ Pipe Lined
Invert Depth: **27.65** (ft.) Flow Characteristics: **Fast**
Deposits: ☒ None ☐ Mud ☐ Sludge ☐ Debris ☐ Grease
Silt Depth: (in.) Deposits Extent:
Infiltration: **None** Pipe Seal Cond: **Sound**
